RE: 2014 Natural Gas Standard Inspection – Ritzville District

WASHINGTON UTILITIES AND TRANSPORTATION COMMISSION
2014 Natural Gas Pipeline Safety Inspection
Avista Utilities Corporation – Ritzville District

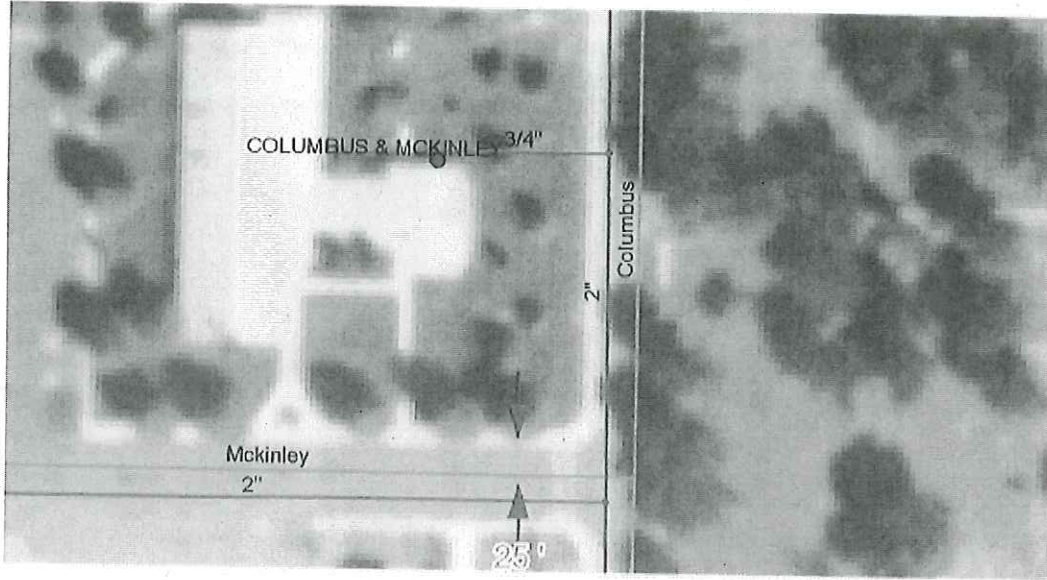
Goldendale, WA

Below are 3 examples of HOS leak surveys where the main was not leak surveyed. In one case, the main was approximately 27' behind the HOS and was not surveyed. It was closer to the structure than segments of the service which were surveyed.

Columbus & McKinley
LDS Church
88' svc
main 14' WCL — not surveyed

We believe it was the intent of the rule that the entire service and any mains in the right-of-way surrounding the HOS or area should be surveyed. More specifically, any facilities where leakage with migrating gas could reach and enter a building or reach and endanger the public in an area where the public regularly congregates. We concur with Avista's personnel that the rule could be better written so that the intent is more clear.

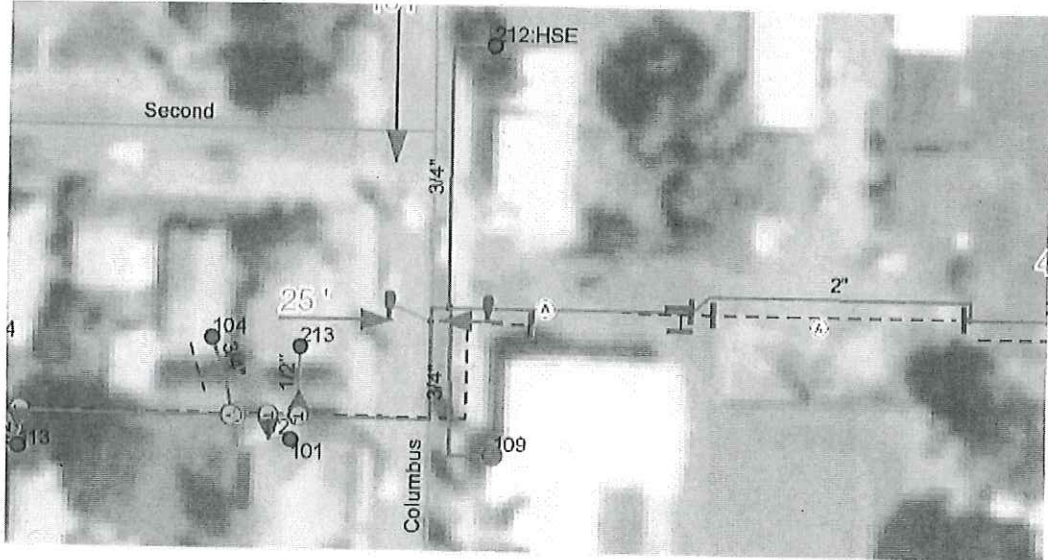
Goldendale, WA

109 Columbus
svc surveyed
no main surveyed
main was 27' N of the church (2")
