Subject: 2017 Natural Gas Standard Inspection – NW Natural Columbia Gorge Unit
(Insp. No. 7241)

On October 16-26, 2017, the Washington Utilities and Transportation Commission (WUTC) staff conducted a standard inspection of NW Natural's (NWN) Columbia Gorge Unit. The inspection included a records review and inspection of the pipeline facilities, and indicates four probable violations as noted in the enclosed report and one area of concern, which unless corrected could potentially lead to future violations of state and/or federal pipeline safety rules. This letter is in response to the findings of Inspection No. 7241, dated November 17, 2017.

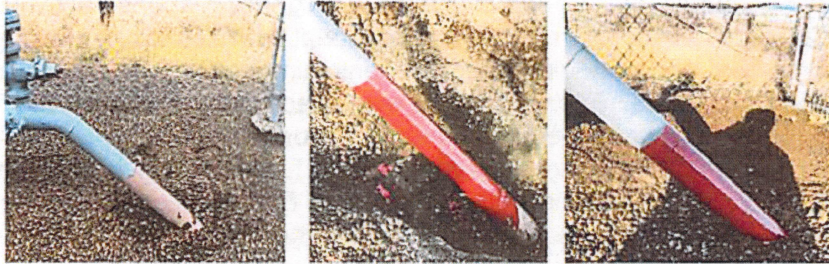
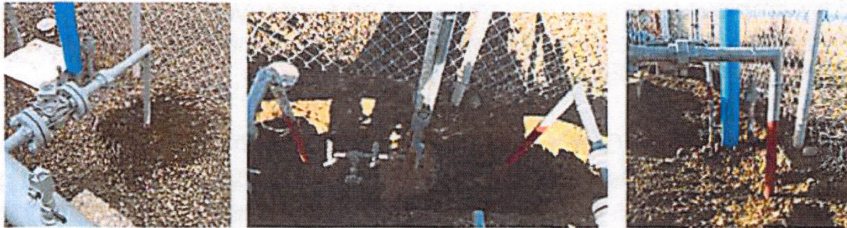
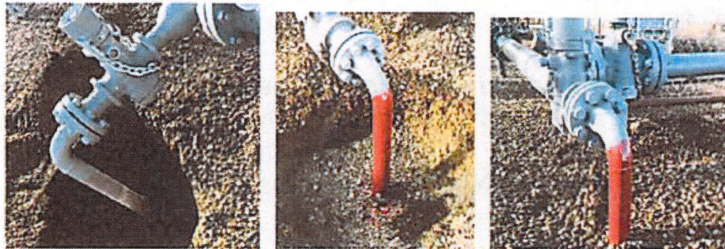
During the field inspection of the Klickitat Gate Station, staff noted that there was visible corrosion at the soil-to-air interface of regulator station piping. The 2016 gate station inspection by NWN indicated that no corrosion was present at this station.

NWN appreciates staffs concern and would like to assure staff that this has been corrected.
Please see before and after photos below-

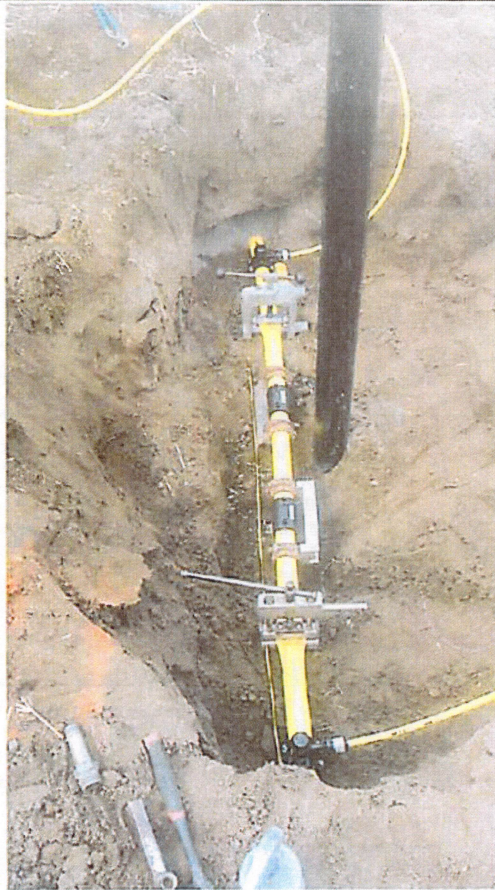
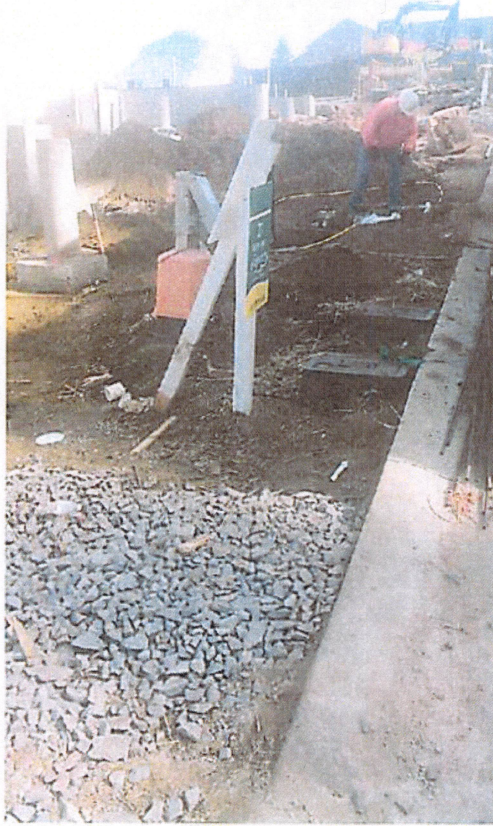
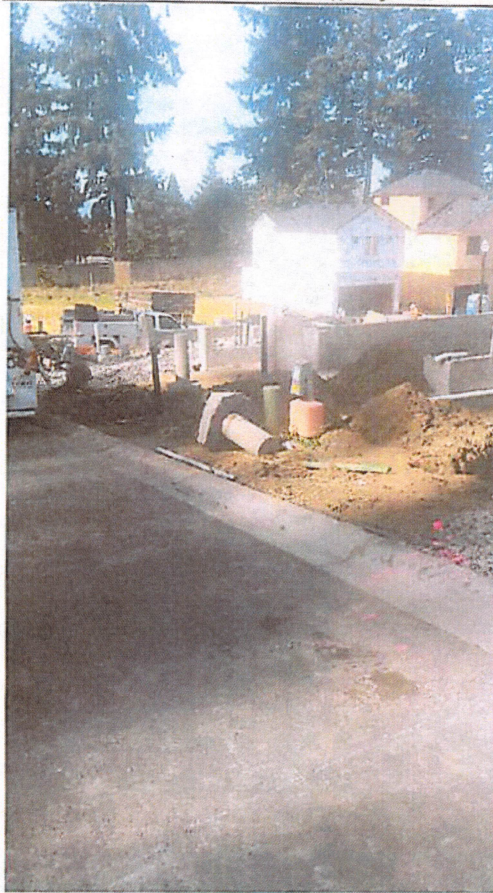
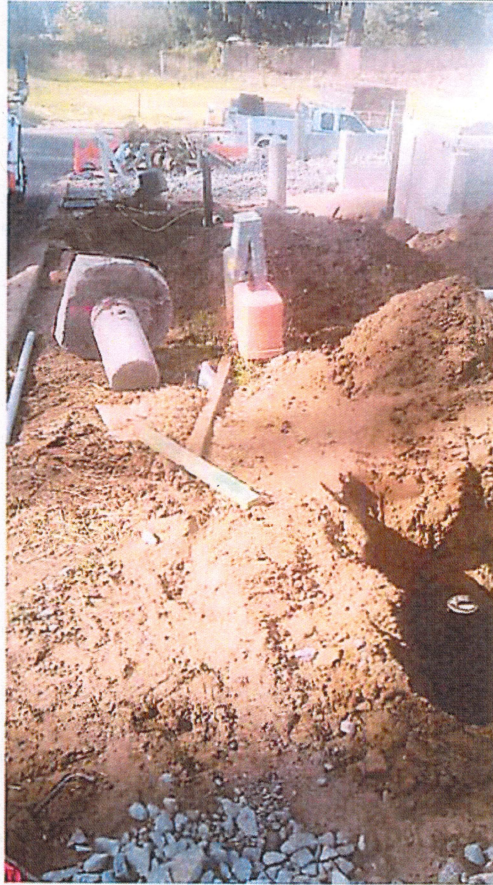
Damage Date: 10/9/2017 Work Request No: 03520460
 Damage Depth: 29 Repair Completed: 134535
 Found Gas Controlled: Gas Controlled Shut Off:
 Damage Type: POLY_SCRATCHED Num. of Customers Affected: 0
 Location: INSIDE_PL Material: POLYETHYLENE
 Damaged Facility: MAIN Damaged Facility (other):
 Pre-Located: NO_LOCATEREQUEST Pre-Located (other):
 Explanation of Repairs and Materials Used: REPLACED 2' 2" P TESTED ON SITE AT 105# FOR 40 MIN. (PASSED) SOAP TESTED FINAL CONNECTIONS AT LINE PRESSURE (PASSED) LIKED 2' 2" P 2-2" INNOG7 COUPLINGS

Earthworks Excavation digging for sewer install hit and damaged 2"(P) main. No locates.
