UTC Incident Investigation Form

Notification ID:	3606	Investigation ID:	8117
-------------------------	------	--------------------------	------

Operator:	Cascade Natural Gas Corporation (CNGC)
District/Unit:	Mount Vernon
Location:	908 E Fulton St Mount Vernon, WA
Incident Date:	November 25, 2019

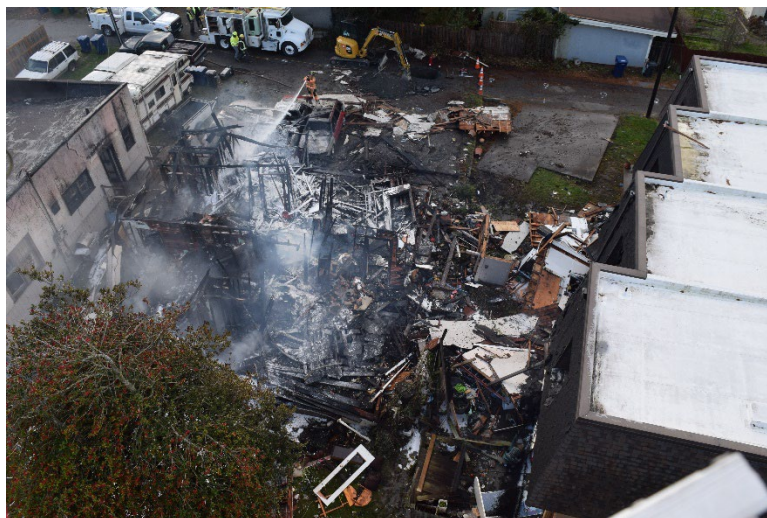
The structure fire was due to an explosion in Unit 2 of a duplex at 908 E Fulton St (**Figure 1**). The occupant from Unit 2 was taken to Skagit Valley Hospital and then Harborview Medical Center for treatment of burns. The occupant in Unit 1 was treated and released at the scene. No deaths and no other injuries were sustained from the explosion/fire.

Figure 1 – Aerial view of the duplex following the explosion. Image provided by MVFD

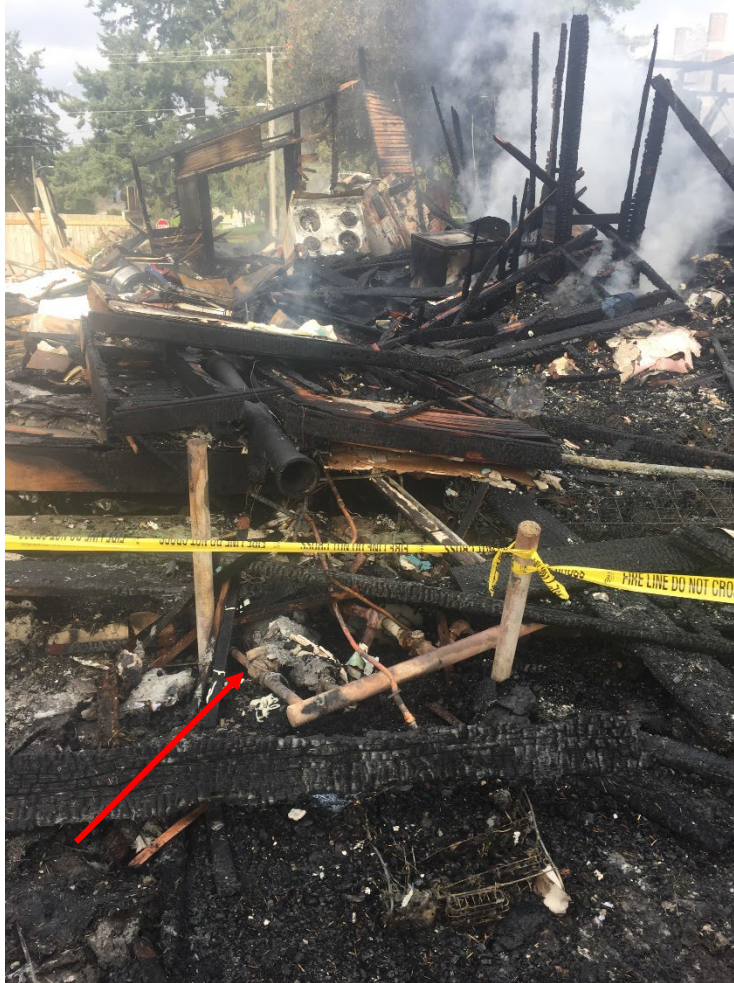
Based on evidence from the scene, interviews with witnesses, CNGC records, and the Origin and Cause Report from Mount Vernon Fire Department (MVFD), the initial explosion does not appear to be caused by CNGC jurisdictional facilities. Although CNGC facilities did not cause the initial explosion, the riser to the gas meter did break which contributed to the amount of fire damage to the structure and other nearby buildings. The riser broke below the service valve (**Figure 2**) as a result of the explosion and fed the fire until MVFD contained the fire and CNGC shut off the gas supply. The damage caused by the release of gas exceeded \$50,000 and is therefore reportable under 49 CFR 191.5 (NRC Incident Report #1264834).

Figure 2 – View of the damaged two-meter manifold covered in debris

Although CNGC facilities and operations did not cause the explosion, their facilities did contribute to the fire following the explosion. The meter and riser were damaged during the explosion and fed the fire. This caused additional property damage to the duplex, other buildings and vehicles. This damage exceeded the \$50,000 reporting threshold.

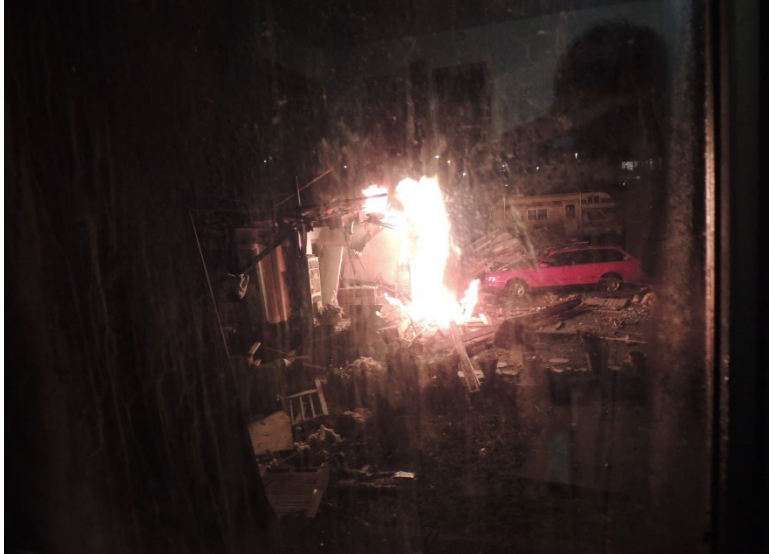
- 5:40 AM to 6 AM – Neighbor (Scott Gassaway) went for a run and smelled natural gas
- 6:12 AM (Approximate) – Explosion occurred according to witness interviews and fire department alarm time (**Figure 3**)

Figure 3 – Fire being fed by the gas meter shortly after the explosion. Picture taken by neighbor, Corban Gassaway

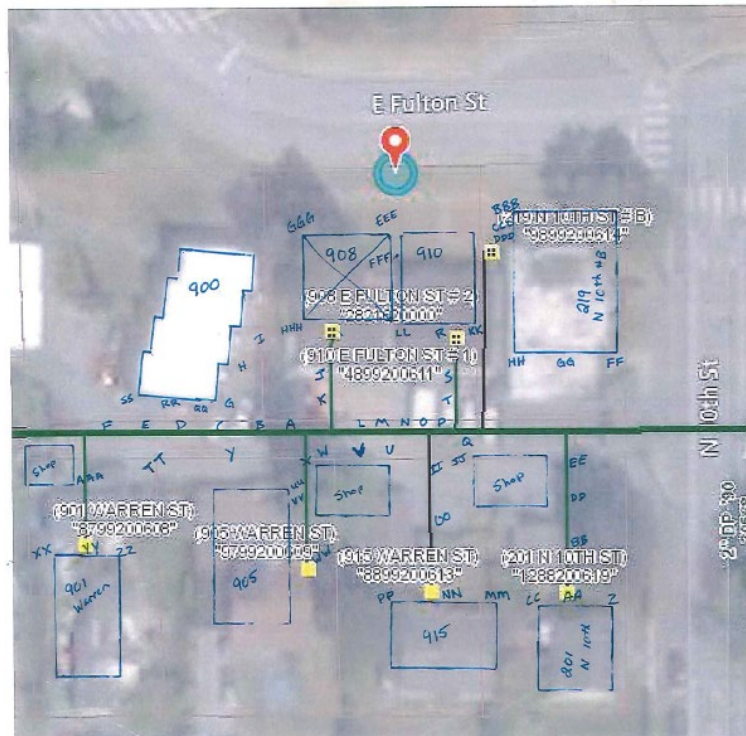
- 7:30 AM – CNGC began bar hole testing over the service line and main in the surrounding neighborhood (**Figure 4**). During initial bar hole testing, CNGC found a gas reading of 4.2% gas-in-air over the service line feeding the duplex.

Figure 4. Map of the locations CNGC performed bar hole testing

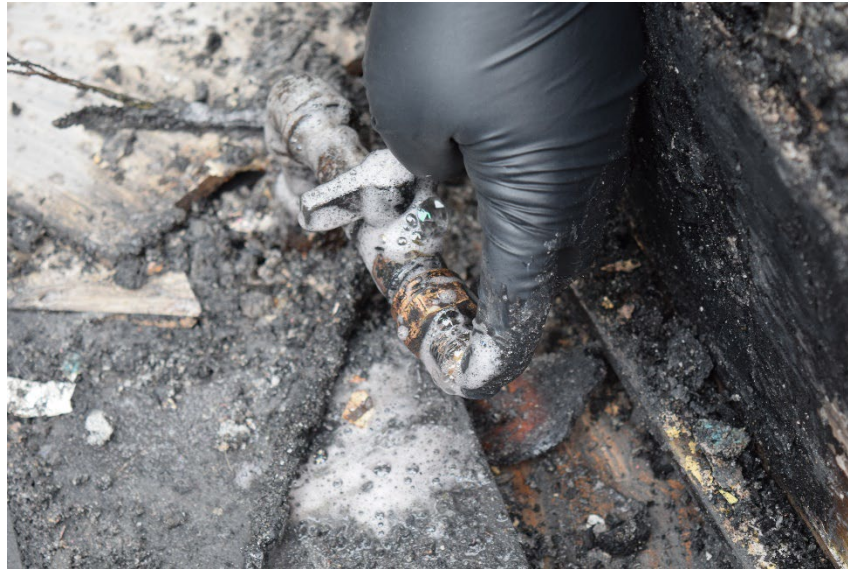
- CNGC and MVFD attempted to air test house piping but the test failed. CNGC soaped the line and saw bubbles forming at the gas valve to the gas furnace. **(Figure 5)**

Figure 5 – Soap test on house piping showing bubbles forming near valve. Image provided by MVFD.

The only system that failed an air test following the explosion was the internal house piping. The house piping was unable to hold air and could be seen leaking at the gas valve to the gas furnace when CNGC soap tested the line. On November 8, 2019, the occupant of Unit 2 had the gas turned back on. At this time the occupant refused access to CNGC personnel to perform a re-light on gas equipment and there do not appear to be any records indicating the occupant had the house piping or furnace inspected by a qualified person prior to gas turn on.
