Re: NW Natural Amended Response to Camas Transmission Line Inspection

The Washington Utilities and Transportation Commission (WUTC) Staff conducted a pipeline safety inspection of NW Natural's (P04) Camas Transmission Line on June 17-19, 2014. This letter is an amended version, reflecting enhancements to NWN's prior response dated September 30, 2014, to the findings of Inspection Report dated August 27, 2014.

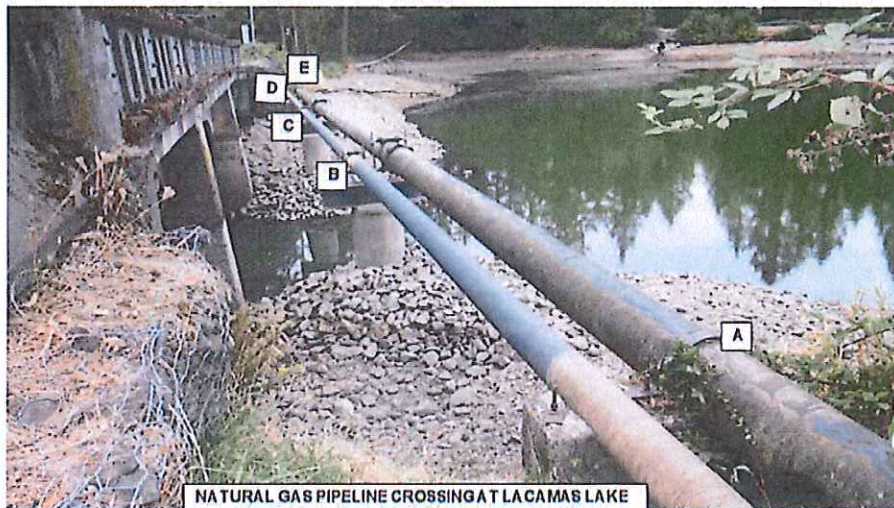
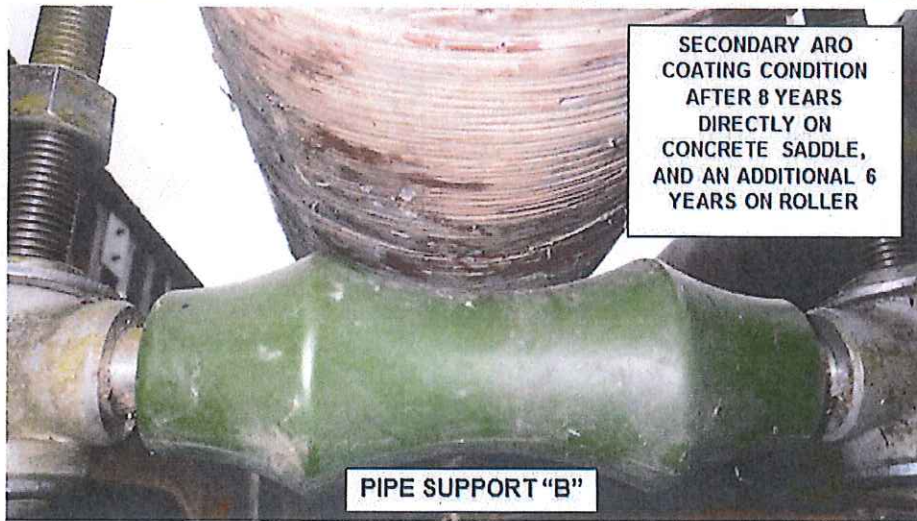
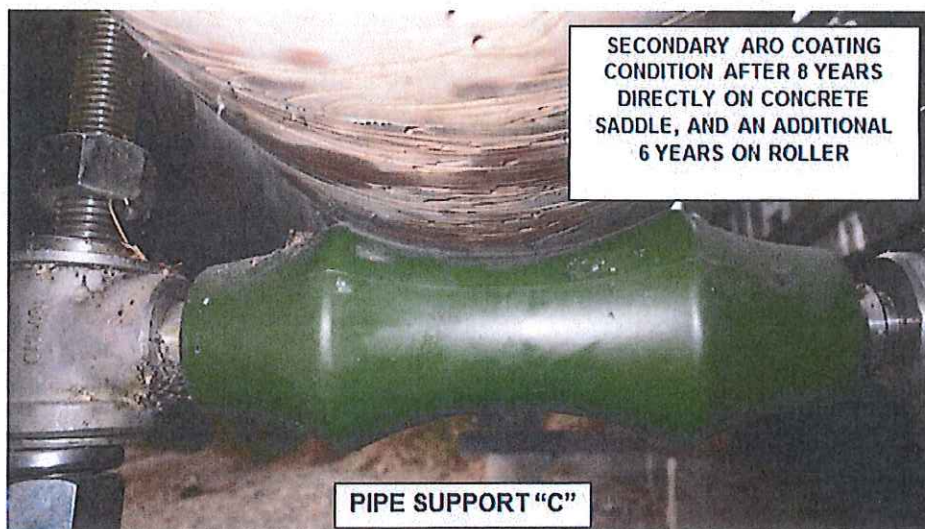
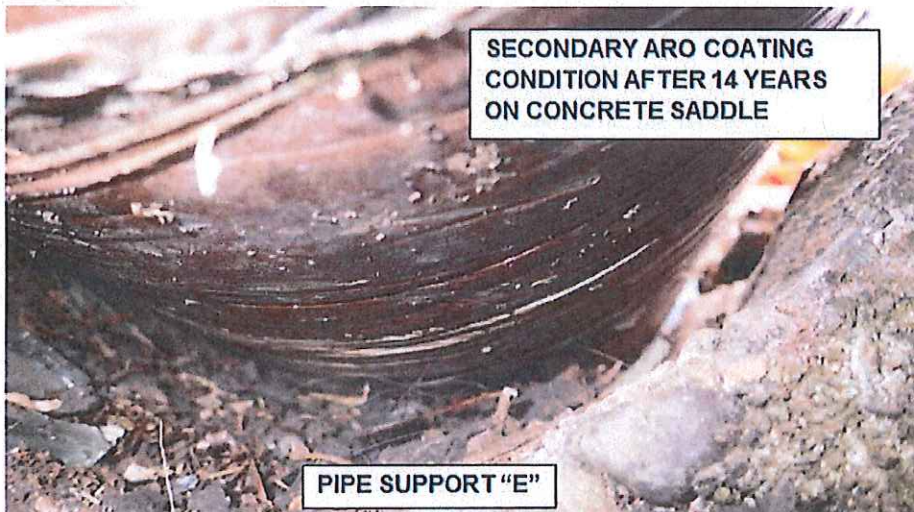
- On September 22, 2014 NW Natural took readings of the existing pipe coating at all five piers at the Lacamas Lake crossing. These readings were taken with a DeFelsko PosiTector (serial # 45-4805-13), ultrasonic thickness tester. This included examination of the coating under the roller pipe supports on the piers that were replaced in 2008. A measurement was taken in each quadrant at all pipe support locations. These readings are summarized in attachment 1 and photos below. In addition, the resulting observations of the coating at each support showed no signs of coating disbondment, abrasion, UV degradation or atmospheric corrosion. In our opinion, the findings demonstrate that the coating system designed and installed in 2000 is effective in meeting the atmospheric corrosion control requirements as stated in 192.479(b).

Visual observation at each pipe support revealed the following:

- A fiberglass reinforced plastic shield is still intact between the three layer coating and the concrete support at locations A and D
- The black primary ARO was not visible in any area containing the secondary ARO (i.e. the primary ARO was fully encapsulated in the secondary ARO layer).
- The green FBE corrosion protection later was not visibly exposed to the atmosphere at any location.
- The coating system is functioning as designed.

After more discussions between representatives of NW Natural and WUTC, NW Natural has agreed to add an inspection question to the Bridgeline Patrol inspection, to document specific attention given to the condition of pipe supports. NW Natural will also enhance the OQ procedure OP-E-120-02 – Patrolling Bridge Crossings to specifically address corrosion inspection at pipe supports and the appropriate reporting protocol if corrosion is identified

Additionally, NW Natural will continue its on-going discussions with the City of Camas regarding their pier replacement project. As the opportunity is presented, NW Natural will install new generation pipe support rollers at this site.
